Manhole Inspection Summary

Manhole # S21M1_009MH

Location Address: **2706 norland-patapsco alley**

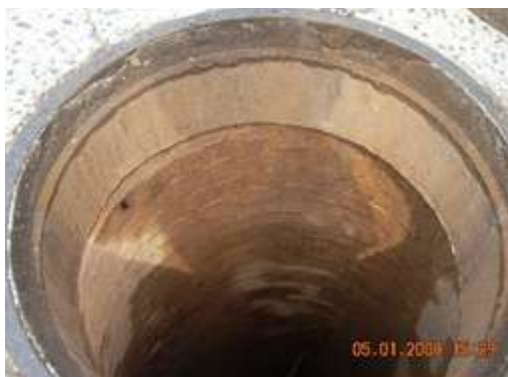
Misc. Defect 1

Subject To Ponding: **Sheeting**

inflow evidence from sheeting

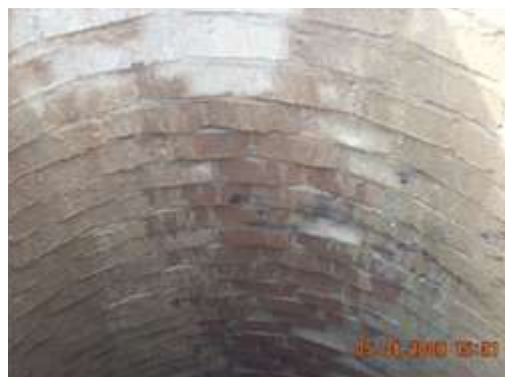
Defect 4

Infiltration: ☐ None ☐ Joint ☐ Cracks ☐ Mortar ☐ Roots ☒ **Wall**

infiltration @ barrel wall

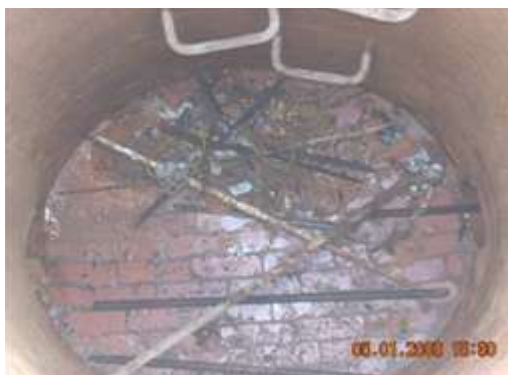
Defect 3

Condition: ☐ Sound ☐ Cracked ☐ Root Intrusion ☐ Deteriorated ☐ Leaks ☒ **Debris**

debris in terminal channel

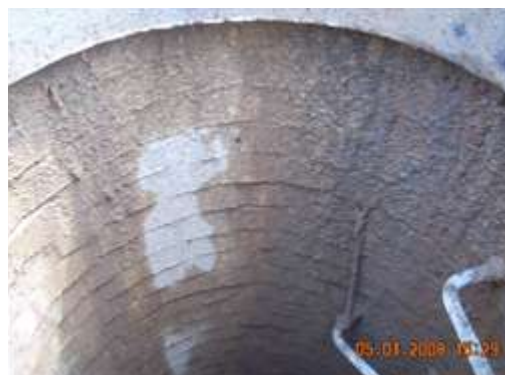
Defect 2

Infiltration: ☐ None ☒ **Joint** ☐ Cracks ☐ Mortar ☐ Roots ☐ Wall

infiltration @ corbel/frame joint

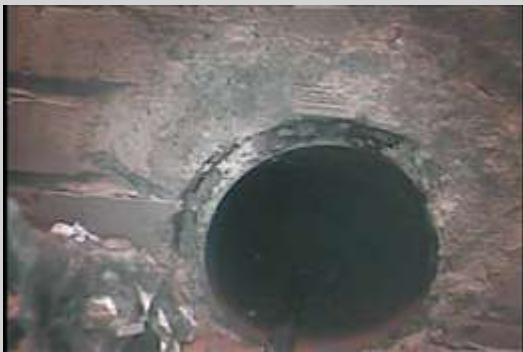
12 O'Clock Outflow

Pipe Height: **8.4** (in.) Rod and Bar (Angled)
Pipe Material: **Clay** ☐ Pipe Lined
Invert Depth: **9.32** (ft.) Flow Characteristics: **None**
Deposits: ☒ None ☐ Mud ☐ Sludge ☐ Debris ☐ Grease
Silt Depth: **0** (in.) Deposits Extent:
Infiltration: **None** Pipe Seal Cond: **Sound**

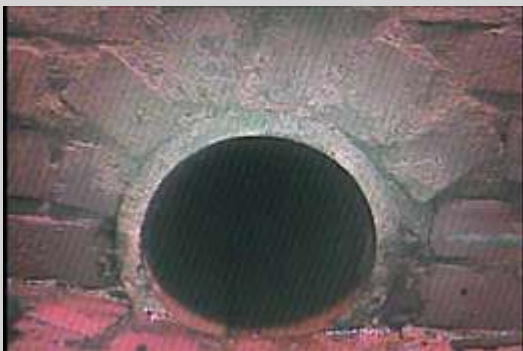
6 O'Clock Outflow

Pipe Height: **8.4** (in.) Rod and Bar (Angled)
Pipe Material: **Clay** ☐ Pipe Lined
Invert Depth: **9.44** (ft.) Flow Characteristics: **None**
Deposits: ☒ None ☐ Mud ☐ Sludge ☐ Debris ☐ Grease
Silt Depth: **0** (in.) Deposits Extent:
Infiltration: **None** Pipe Seal Cond: **Sound**
